The Aisled Barn, Wycoller, Lancashire

Archaeological Survey and Historical Analysis of the Building

September, 2000

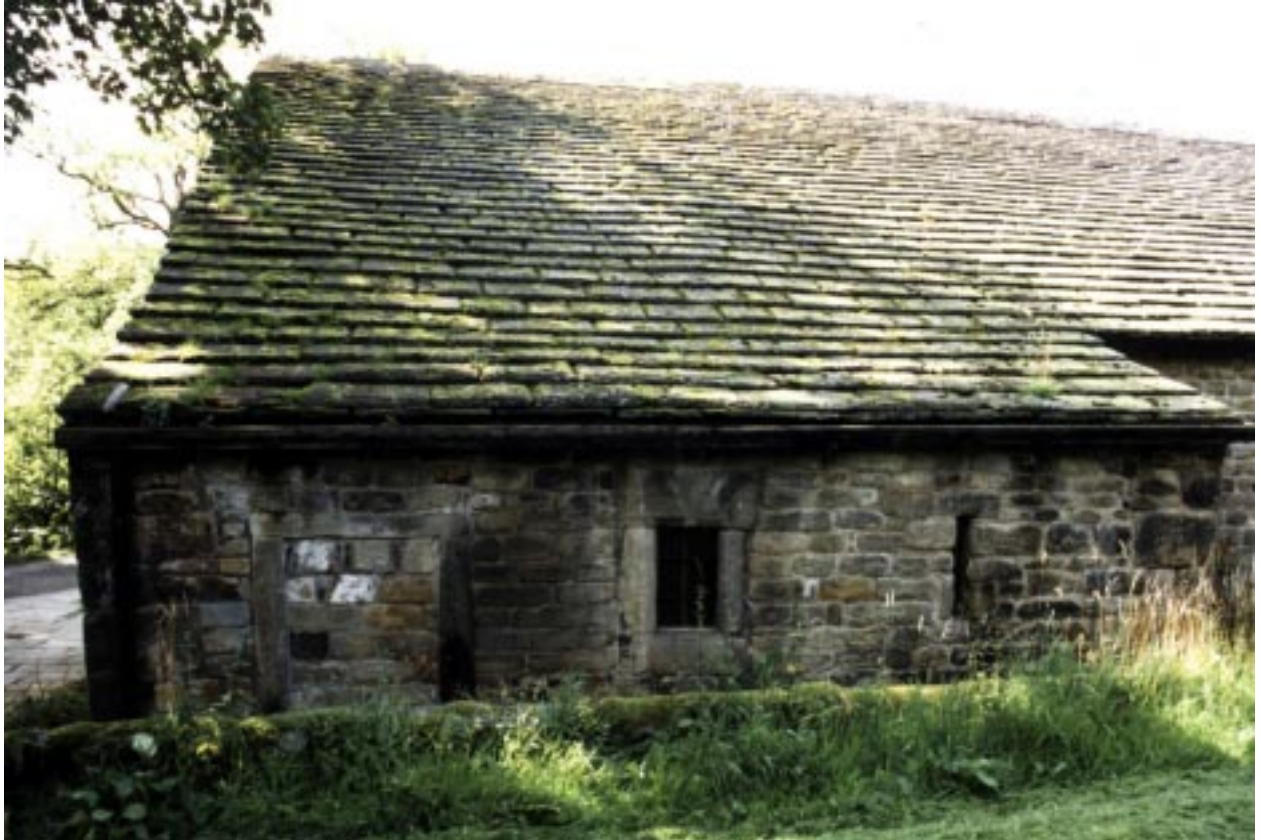
6. Blocked door in outshot probably gave access to feeding passage for cattle

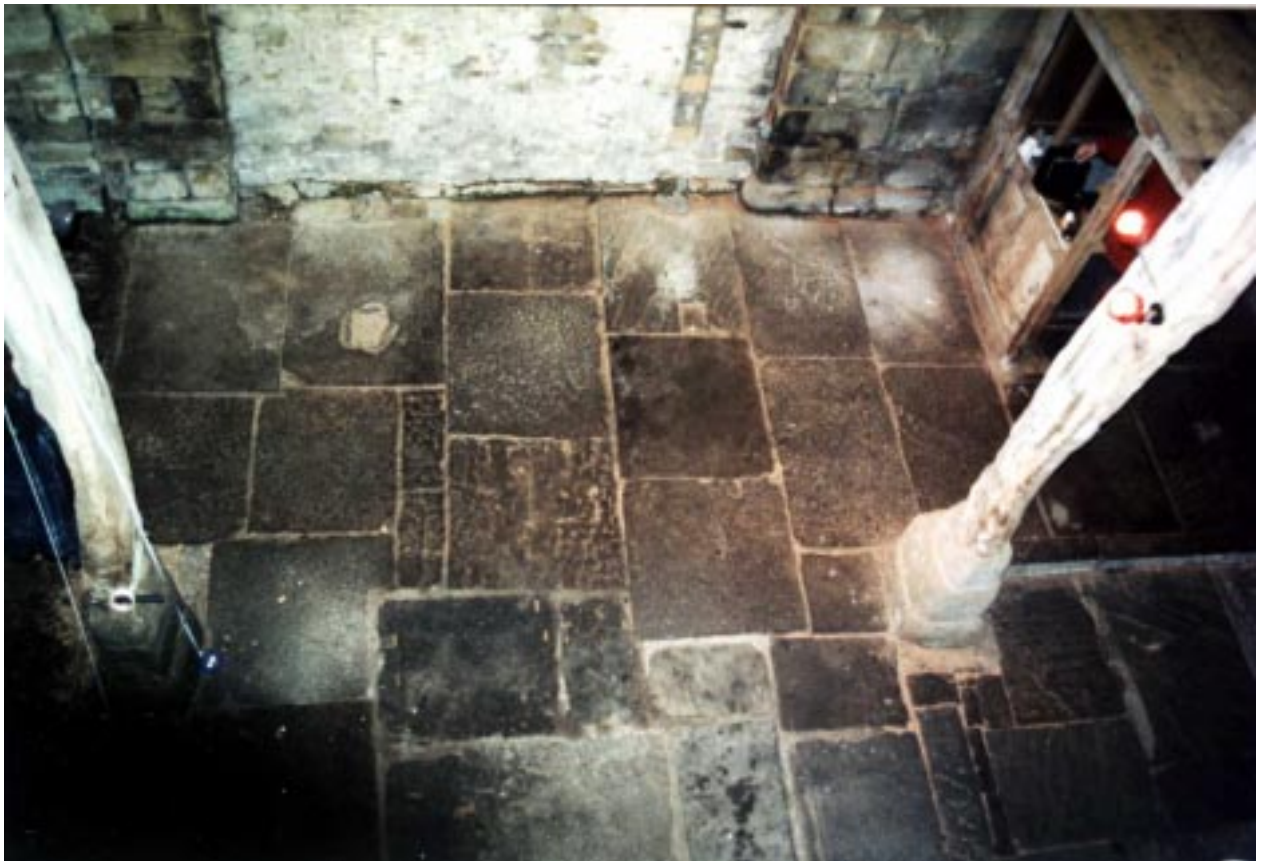
16. Later threshing floor
