The Aisled Barn, Wycoller, Lancashire

Archaeological Survey and Historical Analysis of the Building

September, 2000

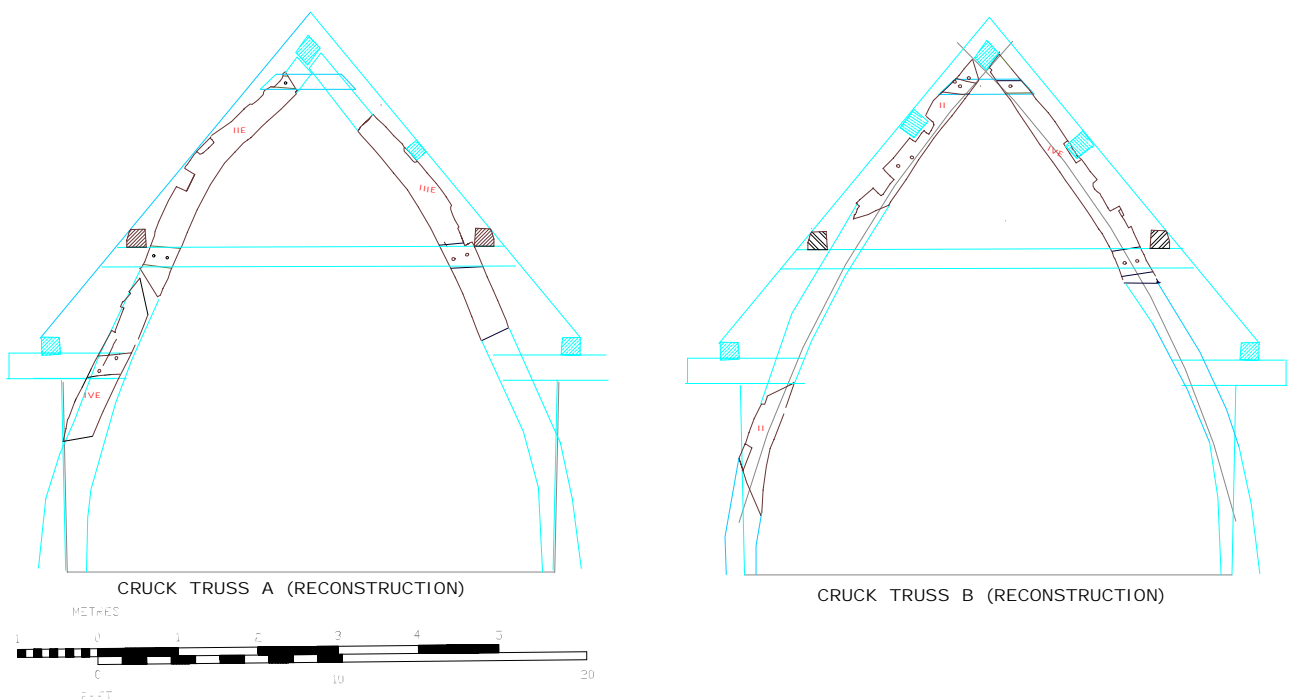
A large proportion of the timbers used to build the aisled barn are re-used from an earlier cruck-framed building which was probably the previous building on the site. From the weathered state of the timbers, it appears that the earlier building may have been partially derelict at some time before it was dismantled. No less than eleven parts of cruck blades can be identified as re-used in the later building and have been used in the reconstruction

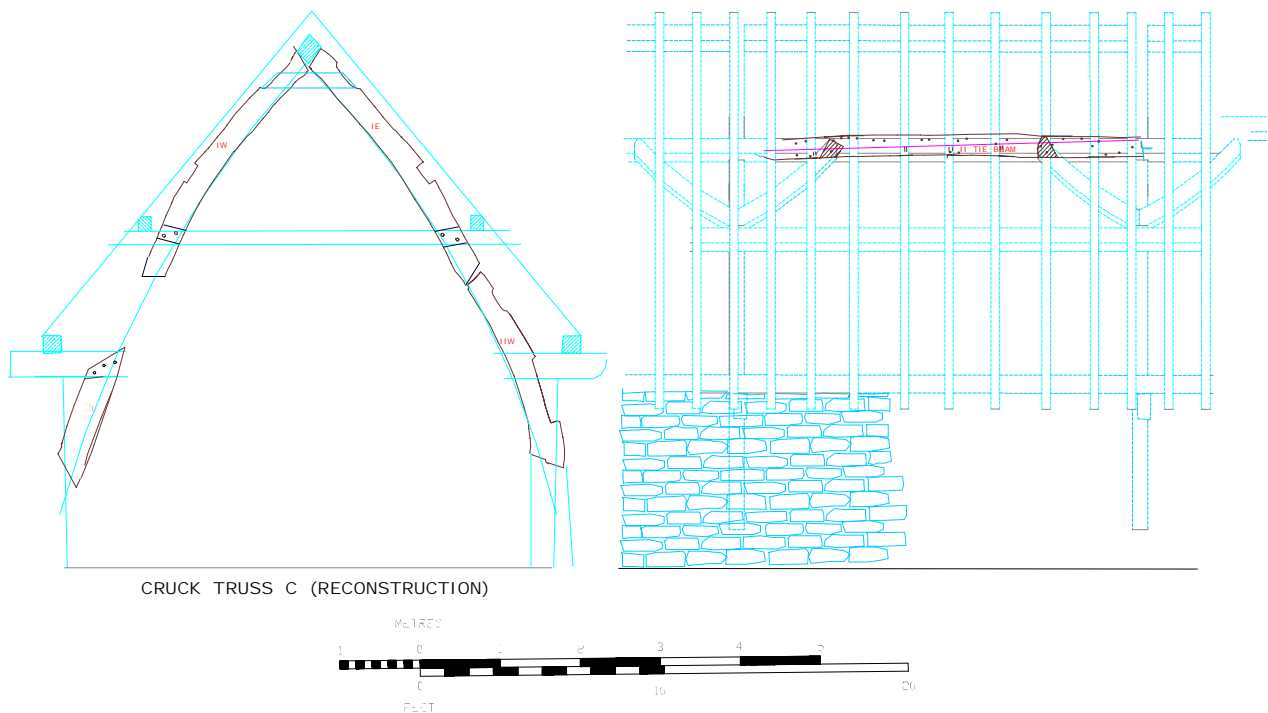
drawings. Cut-down sections of crucks were re-used as aisle ties and as principal rafters in the king-post trusses of the present building. In addition, two purlins and the western arcade plate in bay II/III in the aisled barn have visible halvings demonstrating their earlier use as purlins in the cruck-framed building, but purlins from the cruck-framed barn were also re-used as tiebeams in the aisled barn, at least in cross-frames I and II. The braces in

cross-frame II are sections of massive timbers which also seem to be short sections of cruck blades, but they do not appear to relate to any of the cross-frames which have been tentatively reconstructed. Undoubtedly other timbers in the present building are re-used from its cruck-framed predecessor, but may not be immediately identifiable, because they have been shortened or because the relevant details are concealed.
